PRESERVATION PREVIEW: SPOTLIGHT ON 44TH STREET'S TERRACE PERGOLA

AN ORIGINAL FEATURE OF THE FAMED 44TH STREET CLUBHOUSE FAÇADE, THE PERGOLA TODAY IS SHOWING ITS AGE. RECENT REPAIRS HELPED ADDRESS WORRISOME FLAWS, AND NOW A DESIGN FOR AN EXTENSIVE RENOVATION IS IN THE WORKS, THE TYPE OF PROJECT THAT QUALIFIES FOR SUPPORT FROM THE NEW YORK YACHT CLUB FOUNDATION.

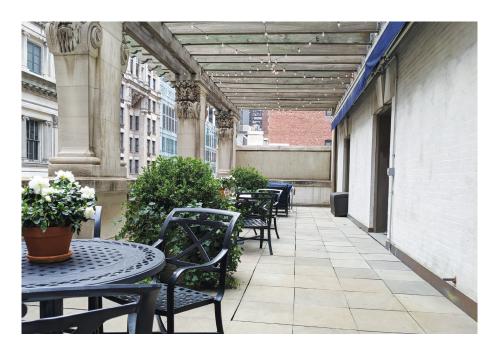
Fast-forward to 2023, and the terrace and pergola still function as an enchanting outdoor space in the heart of the city, but the years have taken their toll. Cracks have developed on numerous pergola timbers; this condition, known as checking, is a natural occurrence when wood is exposed to the elements.

The 44th Street Terrace (opposite), with its pergola canopy, provides an outdoor retreat in the heart of New York City. Recent pergola attention included (above from left): engineers assessing timber condition; a crane in place for repair; accessing the far end of the timbers; reviewing initial pergola repair plans.

Stretching the entire width of the Clubhouse façade, the pergola consists of 42 individual timbers, each projecting a total length of 15 feet out from the façade. The final five-foot curved section of each timber extends above the sidewalk, some 50 feet below. In cases where cracks exist in the outermost curved section of the timbers, there is the danger of pieces falling onto the sidewalk.

When a recent inspection by New York City engineers noted that 37 of the 42 timbers required attention, New York Yacht Club Director of Facilities Julia Ruegg jumped into action and arranged for immediate repairs that included gluing, screwing, clamping and bolting the wood to ensure there was no risk of pieces of the timbers coming loose.
