REBUILDING THE 100-YEAR-OLD-SEAWALL

AFTER A CENTURY OF HOLDING BACK THE WAVES AND TIDES, THE BULWARK AT HARBOUR COURT IS IN NEED OF SIGNIFICANT STRUCTURAL AND COSMETIC WORK

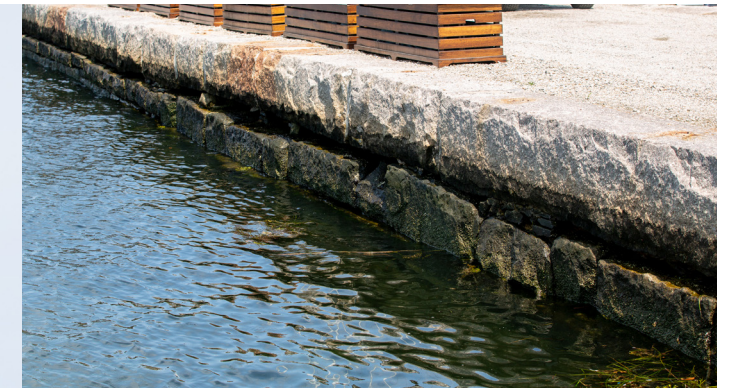
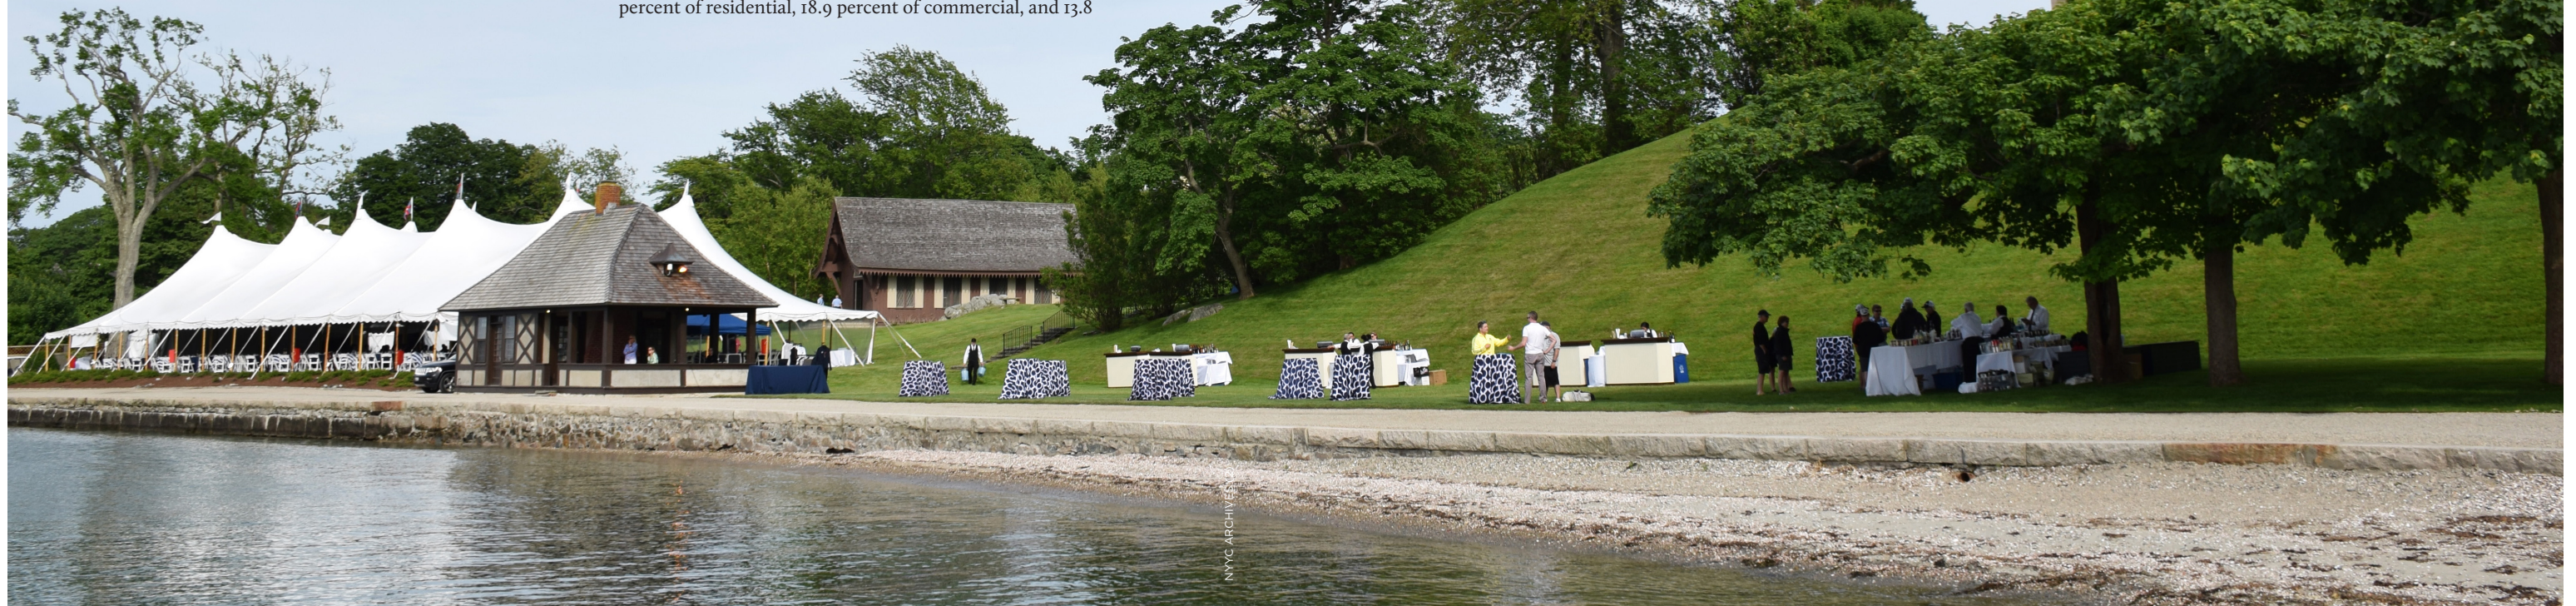
A granite capstone running the length of the seawall creates a unified look, but the wall base was built over time using varied construction techniques; today, more than 40 percent of the wall is in poor condition. Inset above: The leveling course just below the capstone has deteriorated, making the wall uneven.

At Harbour Court, the House Committee’s first step was commissioning a condition evaluation by a coastal engineer, whose report confirmed that a large percentage of the seawall is in poor condition. Large granite blocks comprise most of the wall, unified by a granite capstone, but the crumbling leveling course and the variation in the wall’s elevation—ranging from 3.67 feet high to 5.8 feet high—render the structure unstable.

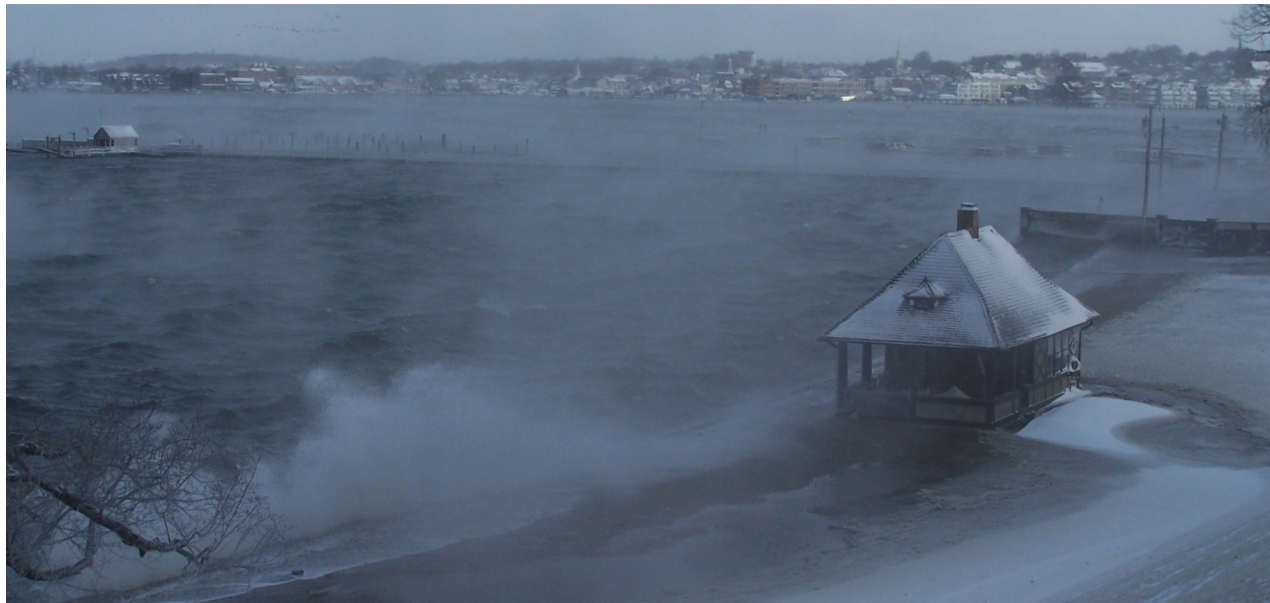
Seawater has been overtopping the seawall more frequently in recent years during storms and high-water events; the boathouse, a whimsical early 1900s structure, is also inundated regularly and needs to be moved slightly inland for protection.

Equally important from a historic preservation point of view is the need to move the boathouse as the seawall restoration takes place. This delightful Tudor-style stucco/half-timbered structure was originally built in the early 1900s as a playhouse for John Nicholas Brown. The current boathouse location is precariously close to the water—just 13 feet away—and the structure receives frequent battering from seawater.
